Application-specific design and proven customer service in seawater service

Conditions

Application:	Seawater transport
Temperature:	85° F (30° C)
Pressure:	2,220 psig (153 bar g)
Valve Model:	T-Series (Trunnion)
Valve Size:	36 inch (900 dn)
No. of Valves:	1

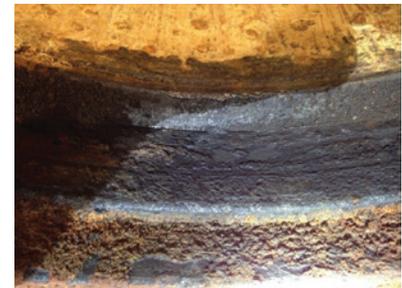
Material loss in the seat pocket was caused by galvanic corrosion, allowing leakage around the valve seats.

Ultimately, the solution came from industry and field knowledge, valve expertise, insanely customer-centric service and innovative valve designs. MOGAS design standards are ideal for corrosive environments, and has experience with seawater applications. Replacement valves were provided with a nickel-based super alloy inlays on all sealing surfaces and through the bore. These valves also used a metal-seated ball valve (not soft seating), supported by a live-loaded disc spring to maintain a tight seal. All external components were painted with an improved paint specification above industry standards to insulate from the salty humidity.

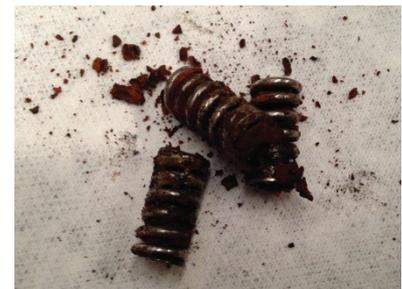
Fine silt packed the coiled spring pockets preventing free motion and an effective seal.
